Manhole Inspection Summary

Manhole # **S11GG1012MH**

Insp Date: **5/22/07 12:48 PM**

Location Address: **4244 GRANTLEY AVE**

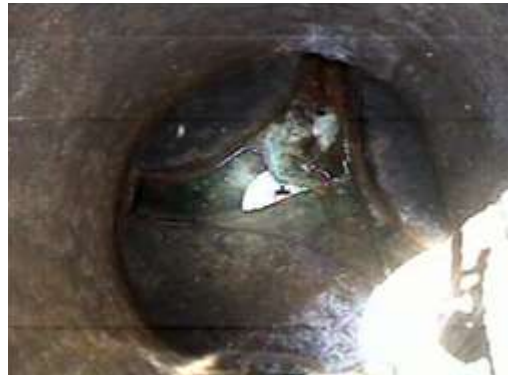
Top View

DEBRIS IN CHANNEL

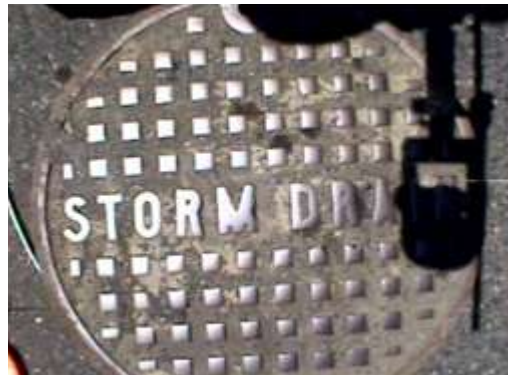
Defect 1

STORM DRAIN COVER

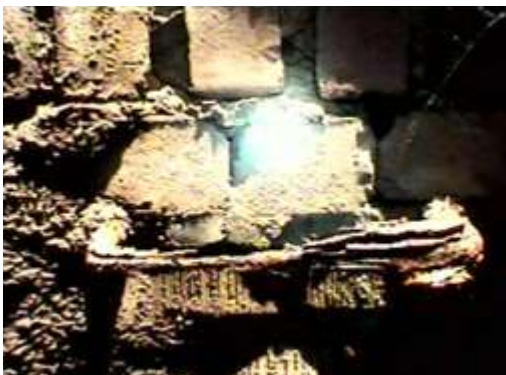
Defect 2

☒ **Corroded**

CORRODED RUNG

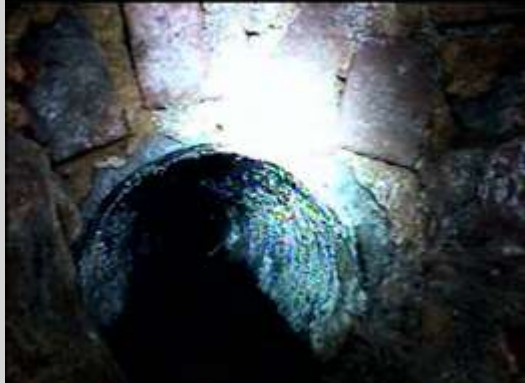
12 O'Clock Outflow

8 in. Circular Gravity Sewer
Pipe Out @ 12 O'Clock

Pipe Height: (in.) Direct
Pipe Material: **Clay** ☐ Pipe Lined
Invert Depth: **8.08** (ft.) Flow Characteristics: **Slow**
Deposits: ☒ None ☐ Mud ☐ Sludge ☐ Debris ☐ Grease
Silt Depth: (in.) Deposits Extent:
Infiltration: **None** Pipe Seal Cond: **Sound**

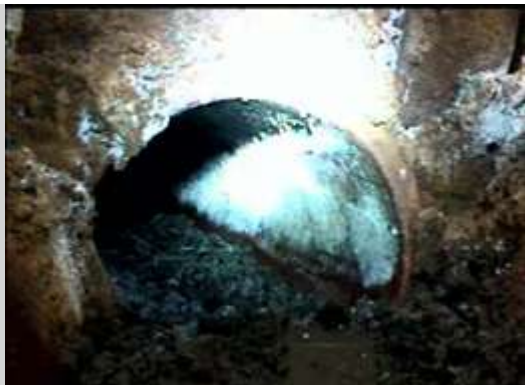
4 O'Clock Inflow

6 in. Circular Gravity Sewer
Pipe In @ 4 O'Clock

Pipe Height: (in.) Direct
Pipe Material: **Clay** ☐ Pipe Lined
Invert Depth: **7.97** (ft.) Flow Characteristics: **None**
Deposits: ☐ None ☐ Mud ☐ Sludge ☒ **Debris** ☐ Grease
Silt Depth: **3** (in.) Deposits Extent: **Medium**
Infiltration: **None** Pipe Seal Cond: **Sound**

Connects To: **Stub connection / abandoned**

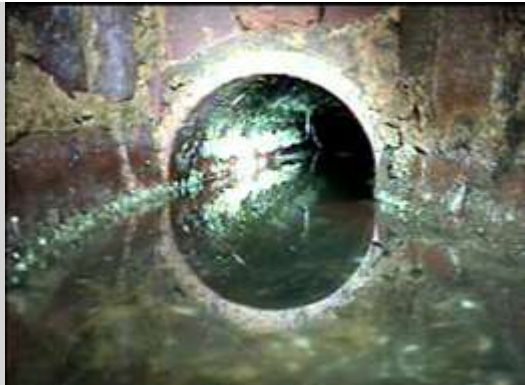
7 O'Clock Inflow

6 in. Circular Gravity Sewer
Pipe In @ 7 O'Clock

Invert Depth: **7.88** (ft.) Flow Characteristics: **Slow**

Deposits: ☒ None ☐ Mud ☐ Sludge ☐ Debris ☐ Grease

Connects To: **House connection / Service line**
